# Project Portfolio

Client	Mystery Workshop t/a Keyhunter
Location	Birmingham
Contract Value	£25,000 +

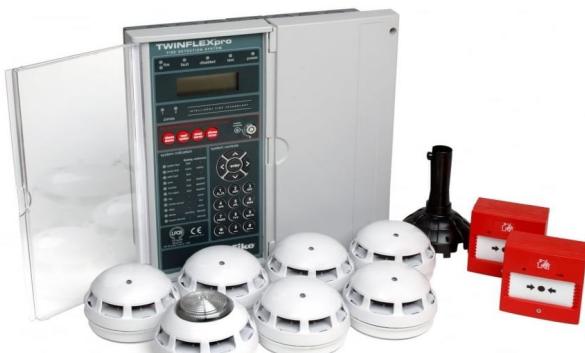
After a survey we decided to install the FIKE Twinflex Pro incorporating the Multipoint ASD Detector with Sounder Bases and Call Points installed throughout the dedicated escape routes.

Emergency Lighting was also installed with 11 x LED Bulkheads within all escape routes and fire exits to ensure that staff and customers could vacate the building quickly and safely.
